TBF/TBM Avenger

Walk Around Number 25
squadron/signal publications

By Lou Drendel

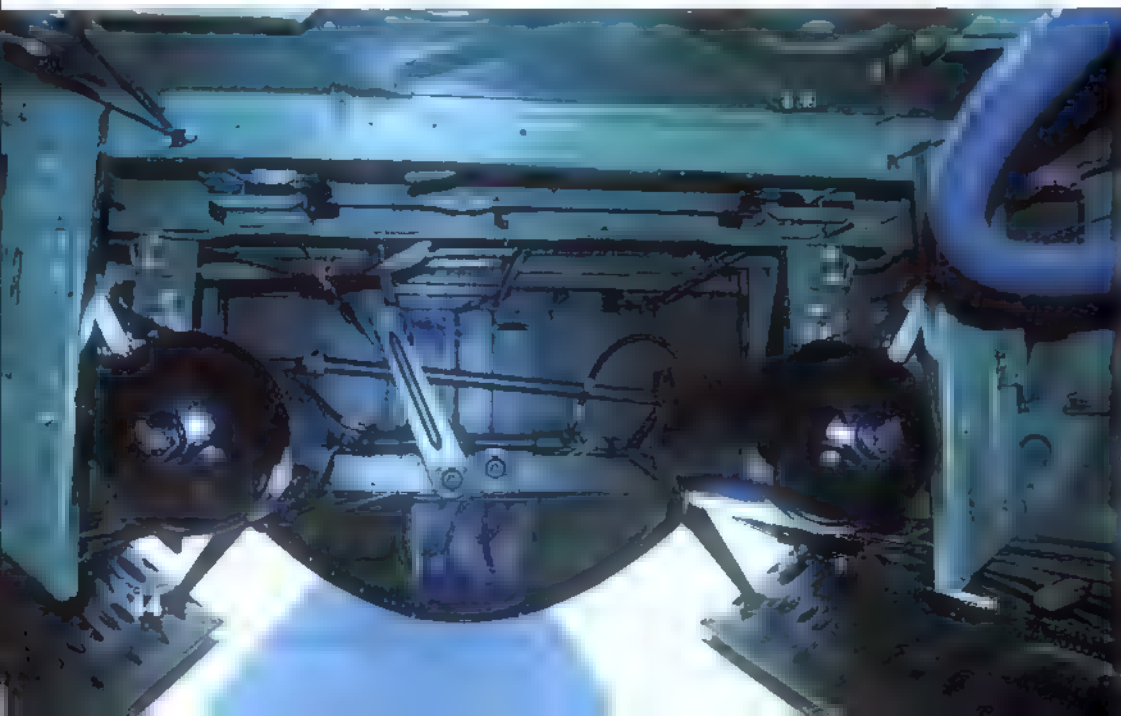
Lightening holes were placed in the bomb bay door inner surfaces to reduce their weight, while retaining the panels' structural strength. Hydraulic lines for bay door operation ran along the edge between the inner door and the lower bay surface. The Avenger bomb bay could also carry a smoke tank for laying smoke screens or a towed gunnery target for air gunnery training. (Lou Drendel)

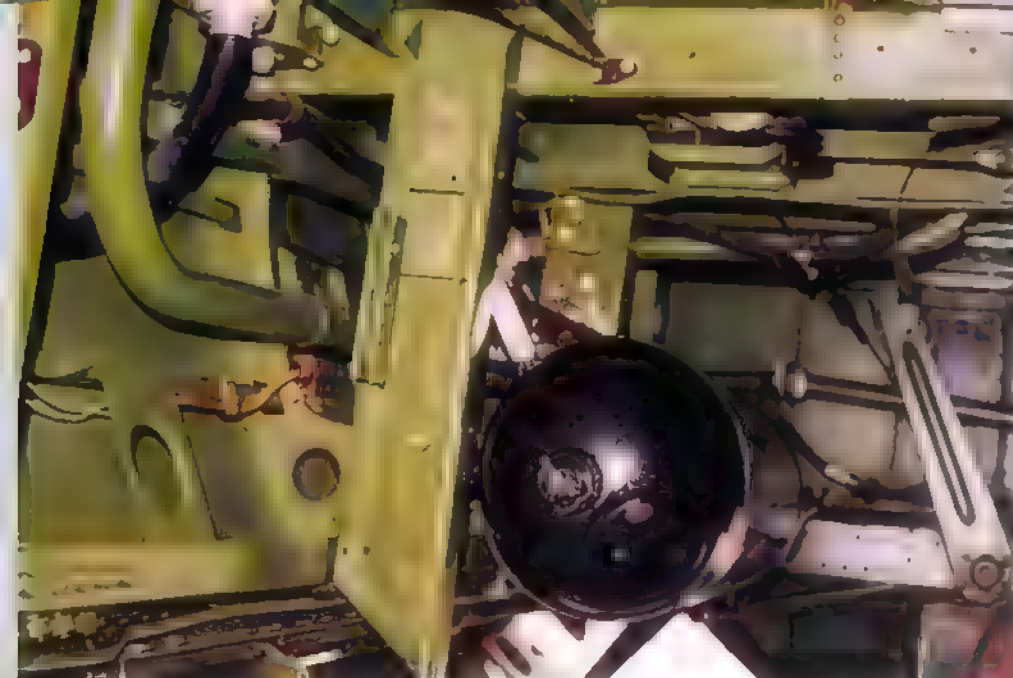
A simulated 100 pound (45.4 kg) bomb was mounted in this restored TBM-3's aft bomb bay section. The bomb is secured to a Mark 8 bomb shackle, which was installed between two vertical beams running from the bay's ceiling. Bombs were released electrically from the shackles, although manual release was available in case of electrical system failure. The Mark 8 bomb shackle became standard during TBM-3 production, replacing the earlier Mark 4 bomb shackle fitted to earlier Avenger models. (Lou Drendel)

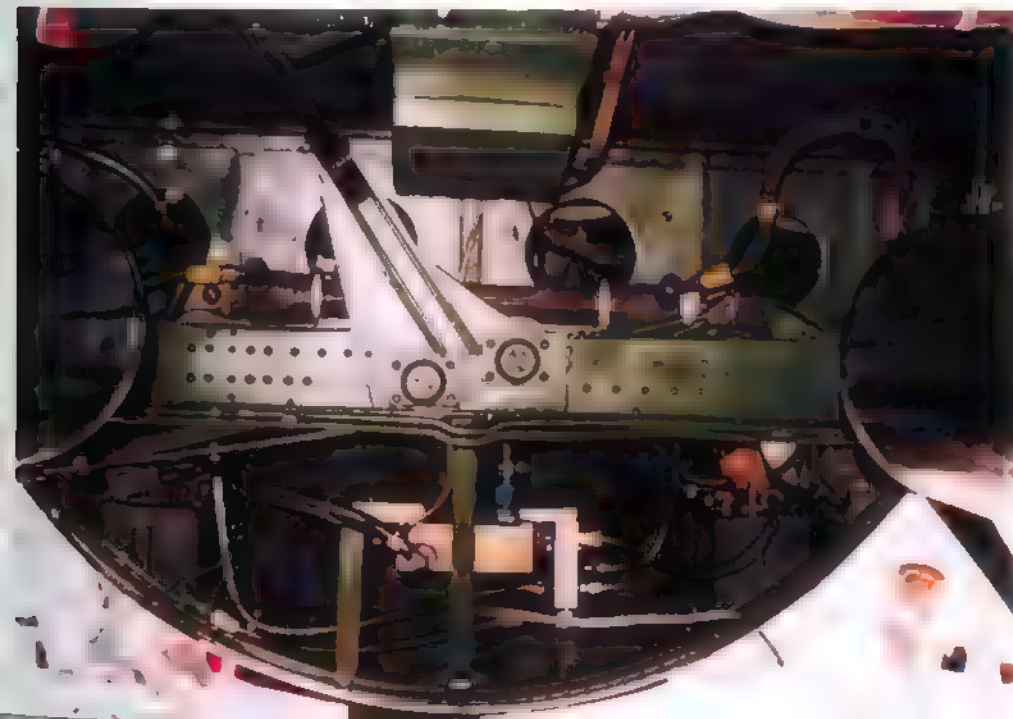
The Avenger's two 12-volt, 34 ampere batteries were fitted to the lower forward bomb bay area, on the port and starboard sides below the forward bulkhead. These batteries – recharged by the engine-powered generator – provided supplemental power to the aircraft's electrical systems. Electrical wiring and hydraulic hoses were placed between the batteries. (Lou Drendel)

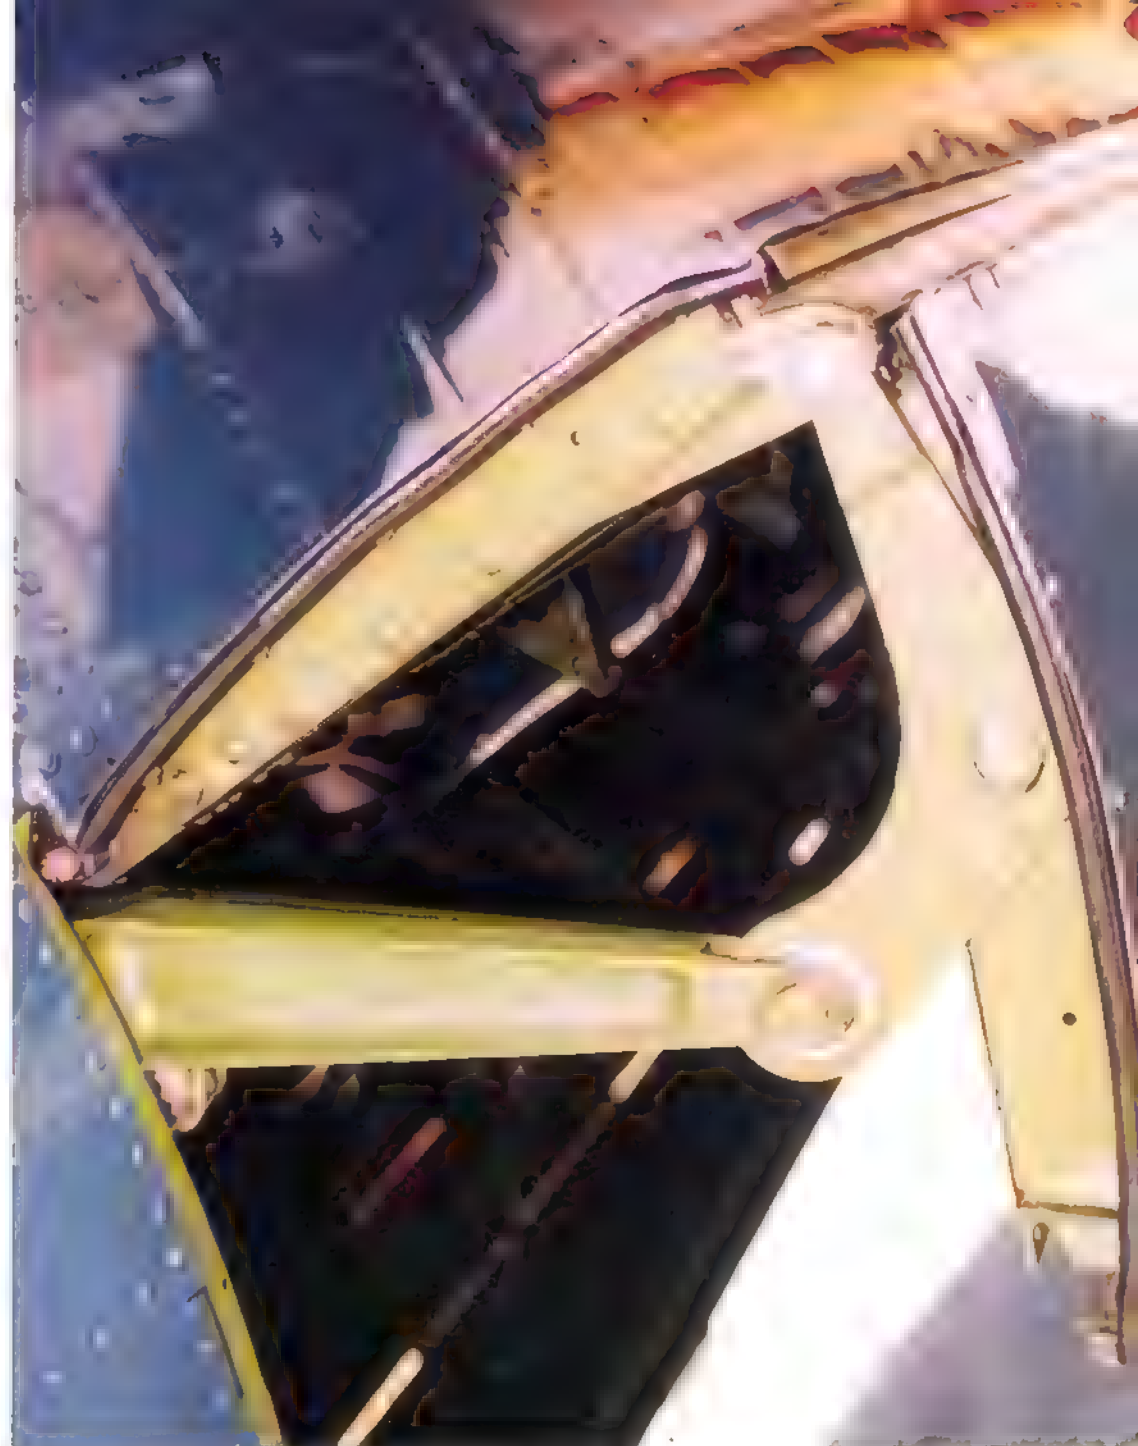
The forward bomb bay door hinge connected the lower fuselage with the inner door, while another hinge connected the inner and outer door sections. The aft bomb bay door hinge was similar in design, although modified to accommodate the angled aft door area. Rubber seals along the doors' edges kept dust and water out of the enclosed bomb bays during flight. (Lou Drendel)

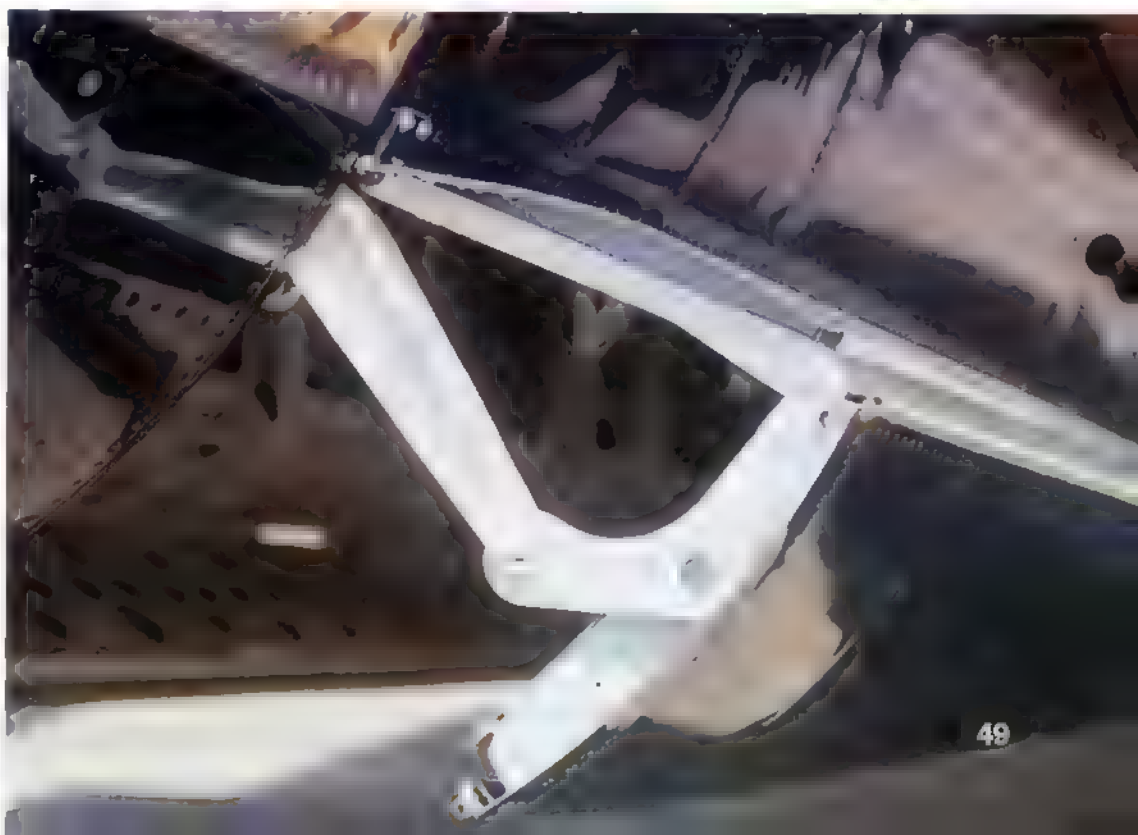
(Right) The forward bomb bay door actuating lever was connected to the inner door, which was hinged with the outer door. The aft door actuator was similar in appearance and operation. The Avenger was the US Navy's first shipboard aircraft equipped with an internal bomb bay. The Vought XTBU-1 Sea Wolf – loser to the Grumman XTBF-1 in the 1939 USN torpedo bomber competition – also had a bomb bay. (Glen Phillips)

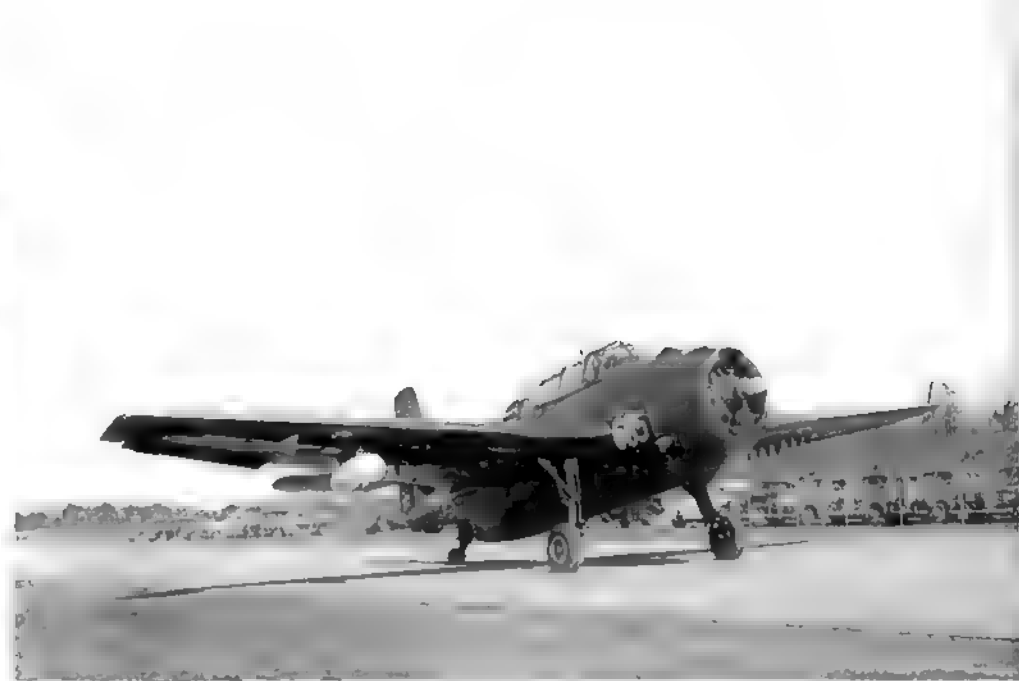
A TBM-3E was parked with its wings folded in 1946. Grumman's wing folding system reduced the wingspan without increasing the aircraft's height, which provided for easier storage aboard aircraft carriers. The wingtip tie-back cable was secured to the horizontal stabilizer to prevent the wing from inadvertently unfolding. (Ed Deigan via Warren M. Bodie)

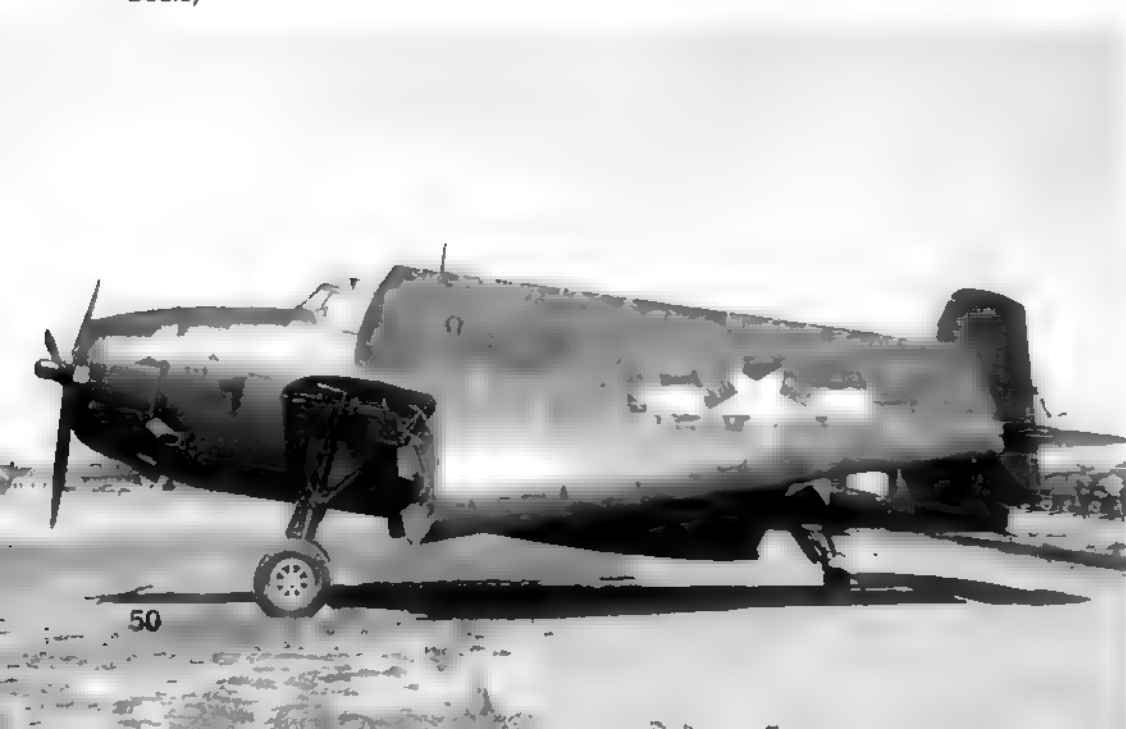
This TBM-3C (BA-284, BuNo 85781) was fitted with four 70 inch (177.8 cm) long Mark 4 rocket launch rails under each wing. These rails – first installed on TBF/TBM-1C aircraft – held four 3.5 inch (8.9 cm) diameter rockets for use against surface targets. The British-designed Mark 4 rails were primarily used on Avengers assigned to anti-submarine duties in the North Atlantic during World War II. (Norman E. Taylor Collection)

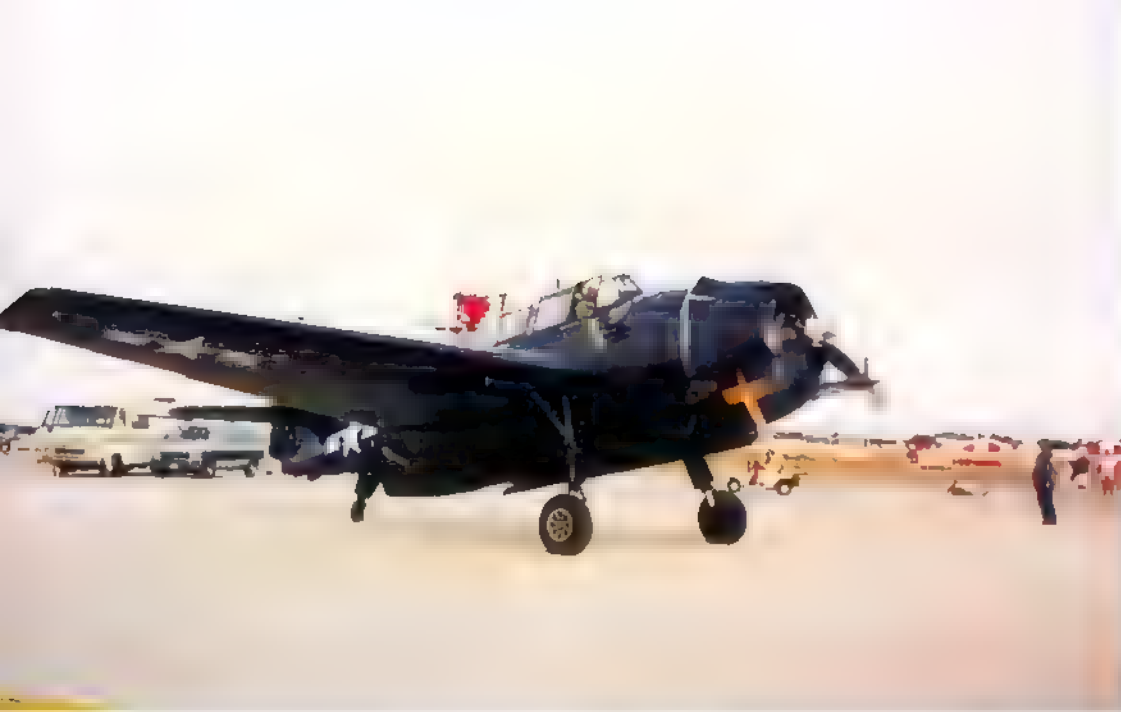
Two 5-inch HVAR replicas were mounted to the folded port wing of this restored TBM. These rockets – painted black with yellow noses – were fitted to Mark 5 zero length launchers. Actual HVARs weighed 140 pounds (63.5 kg) each, measured 72 inches (182.9 cm) in length, and had an effective range of 400 yards (365.8 m). The rockets were aligned parallel to both the fuselage centerline and the aircraft's line of thrust. (Lou Drendel)

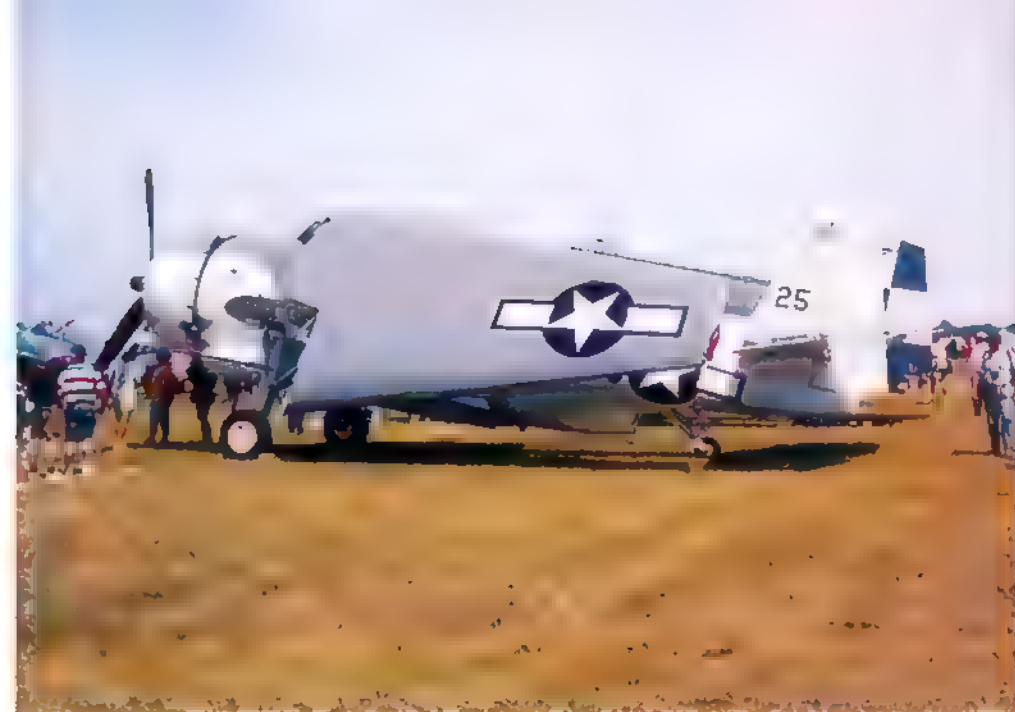
A restored TBM-3 warms up its engine before taxiing at an air show. The wings were usually left extended when the Avenger operated from shore bases. The Avenger had a wing area of 490 square feet (45.5 m²), which combined with the Wright R-2600 engine to help make this aircraft one of the least difficult aircraft to land aboard a carrier during World War II. The responsiveness of the controls and the pleasant handling characteristics made the TBF/TBM popular with its pilots. (Glen Phillips)

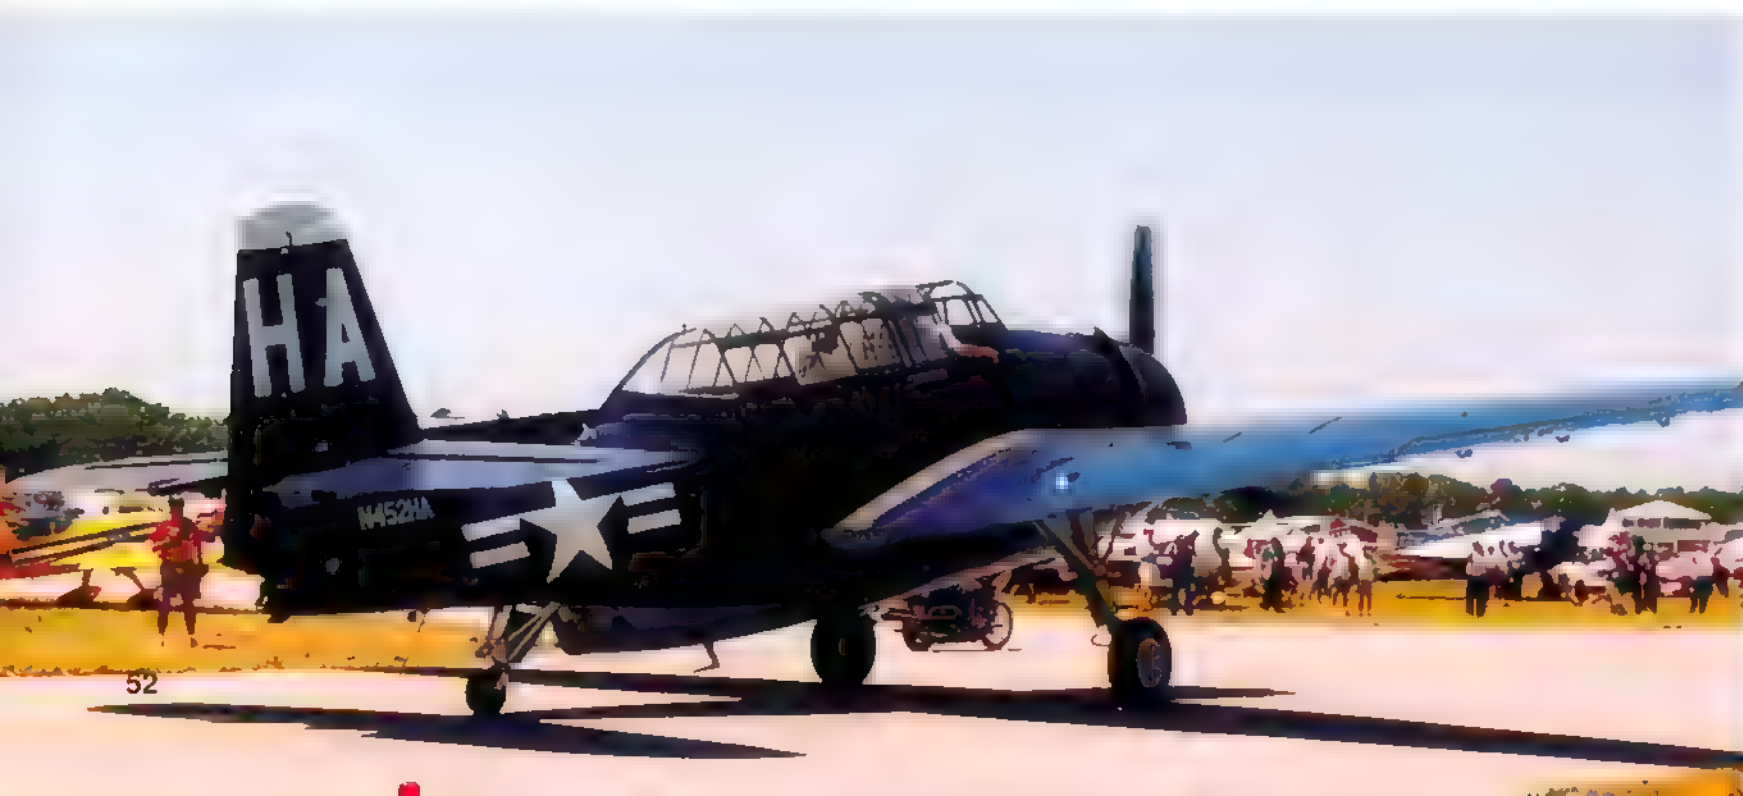
The restored TBM-3 at Elkhart, Indiana folded its wings for display on the flight line. The large size of the Avenger's outer wing surfaces mandated the use of hydraulic wing folding, due to the inability of deck crews to manually fold these large and heavy surfaces. The TBF/TBM's 90° wing folding – which reduced the wing span from 54 feet 2 inches (16.5 m) to 19 feet (5.8 m) – allowed the Avenger to operate from virtually any escort carrier deployed by the Allies during World War II. (Lou Drendel)

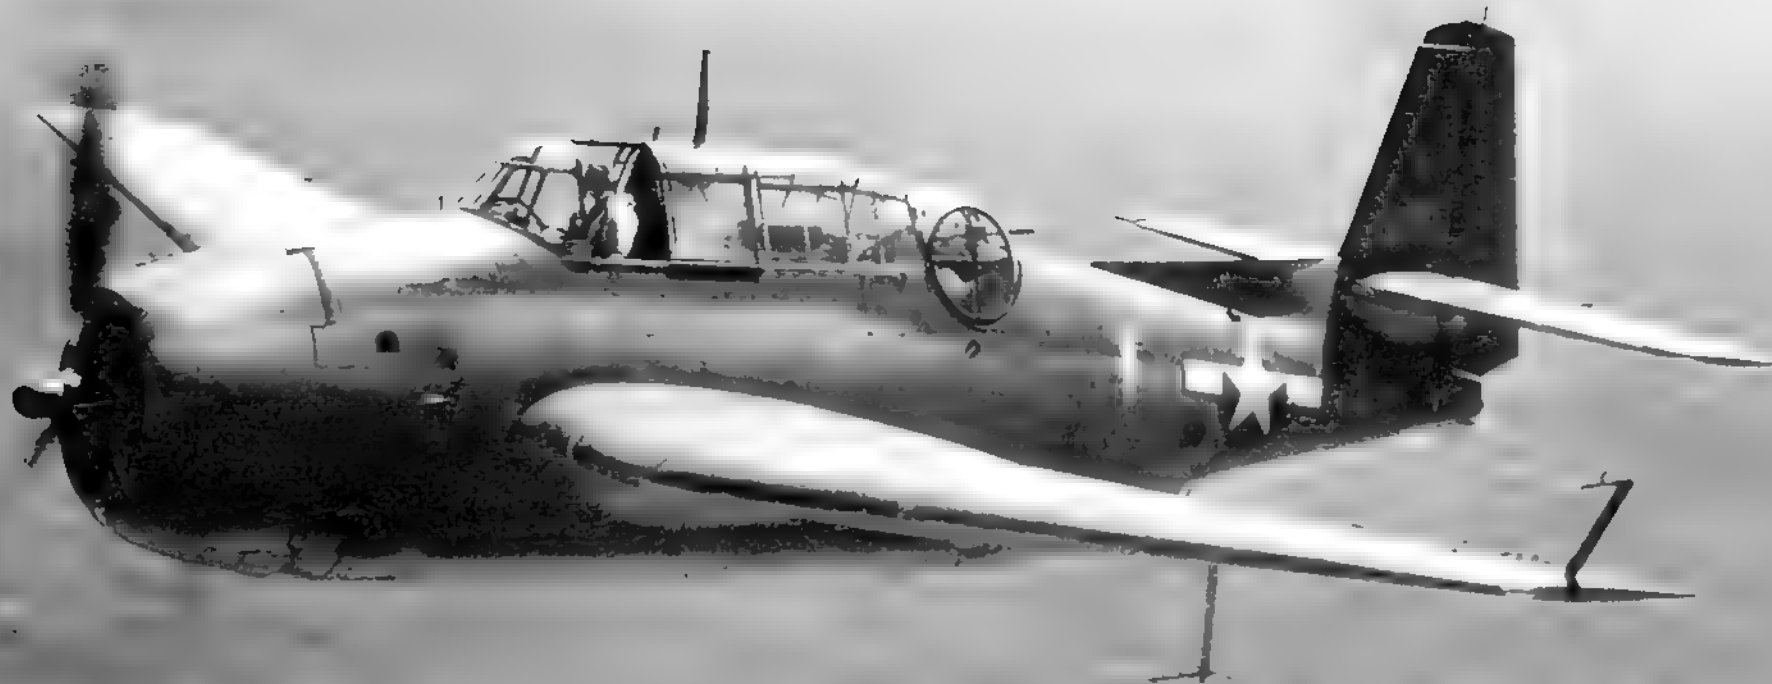
A TBF-1 from an unidentified unit flies on patrol over the Pacific during 1944. This Avenger is equipped with the Westinghouse Air-to-Surface Type B (ASB) radar with Yagi antennas under each wing. The Yagi antenna was mounted 40' outboard, with the array of dipoles able to rotate slightly port or starboard as required. The bombardier viewed the radar

returns on his radarscope, located at his aft fuselage station. ASB radar – fitted to most production TBFs and TBMs – allowed Avenger crews to attack surface targets at night and under most weather conditions. The pitot tube was mounted on an inverted L-shaped fairing placed on the upper port wing tip. (Norman E. Taylor Collection)

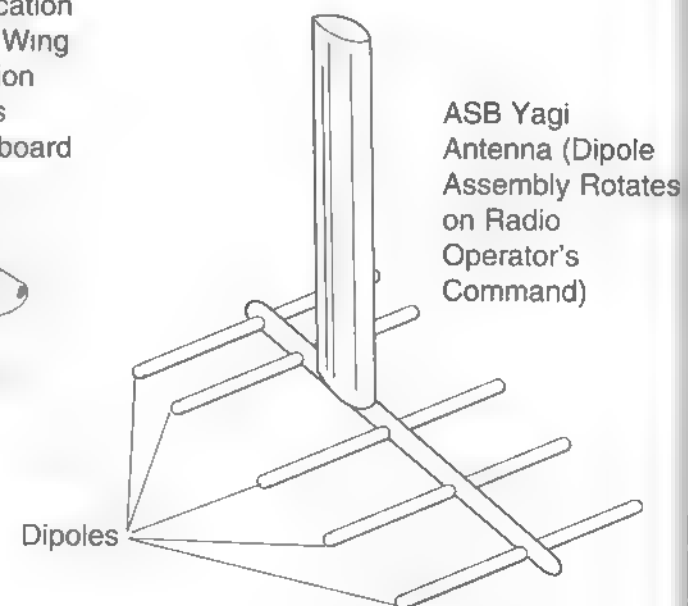
ASB Antenna Location
Under Starboard Wing
(Port Wing Location
Similar) – Dipoles
Mounted 40' Outboard

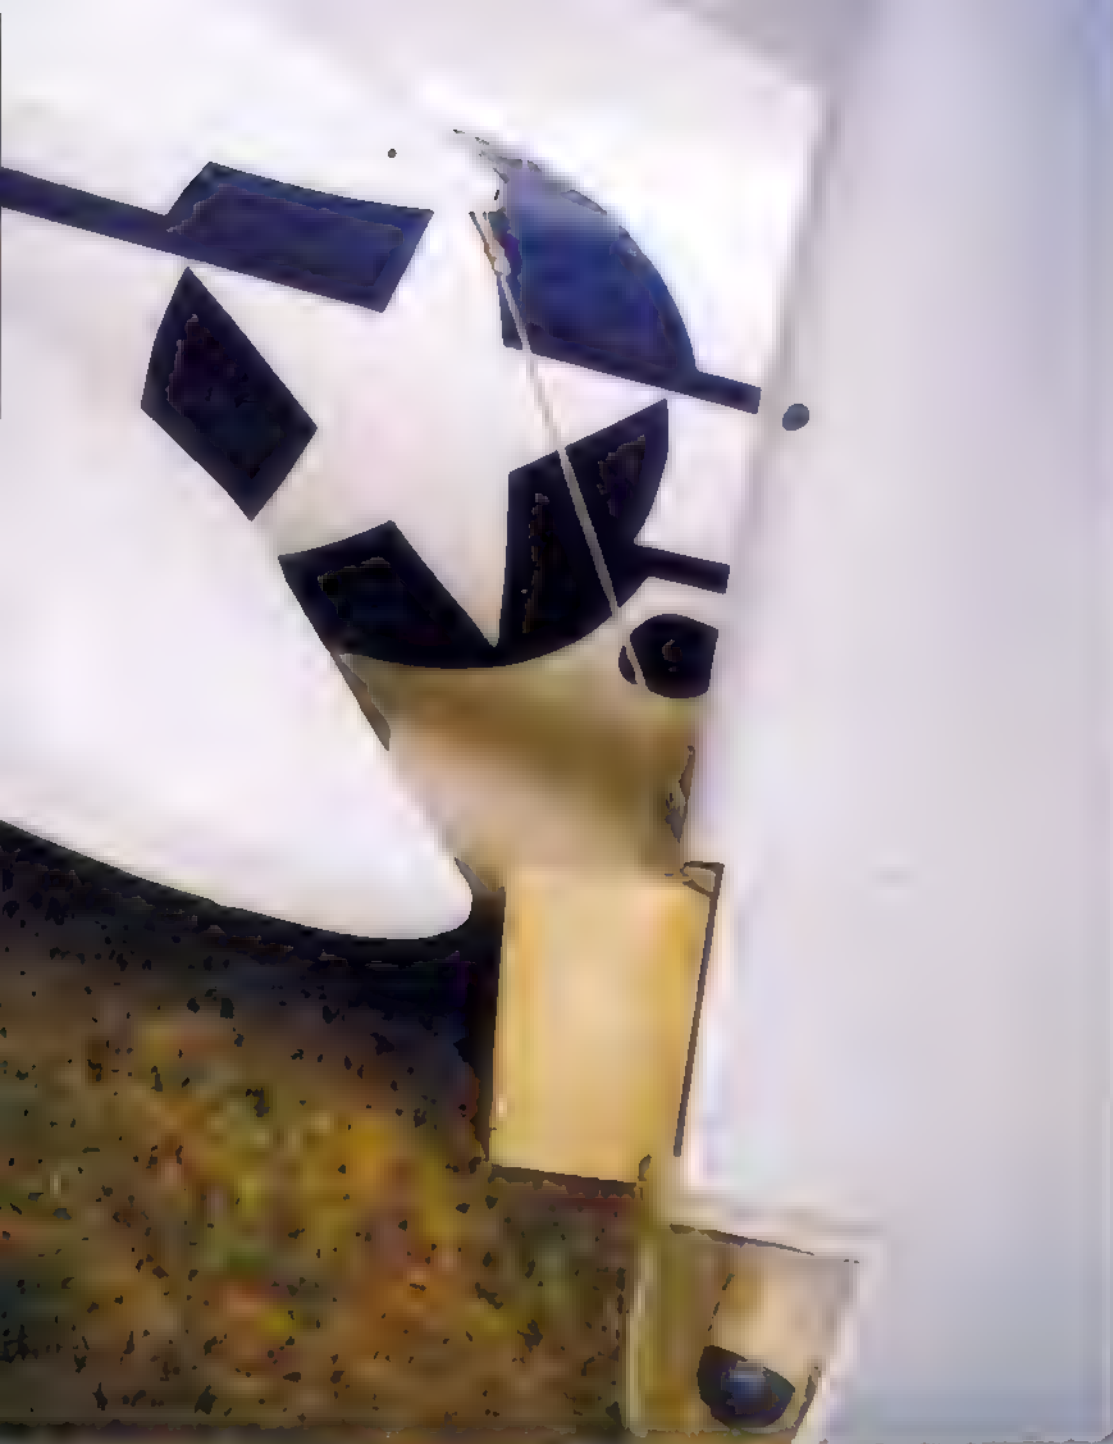
The wing tie-back cable enclosure consisted of upper and lower doors, which conformed to the wingtip's shape and size. These doors were secured with Dzus fasteners – countersunk screws with slotted shanks used to close removable or hinged panels – when the cable was not in use. The tie-back enclosure and door inner surfaces were painted Interior Green (FS34151). (Lou Drendel)

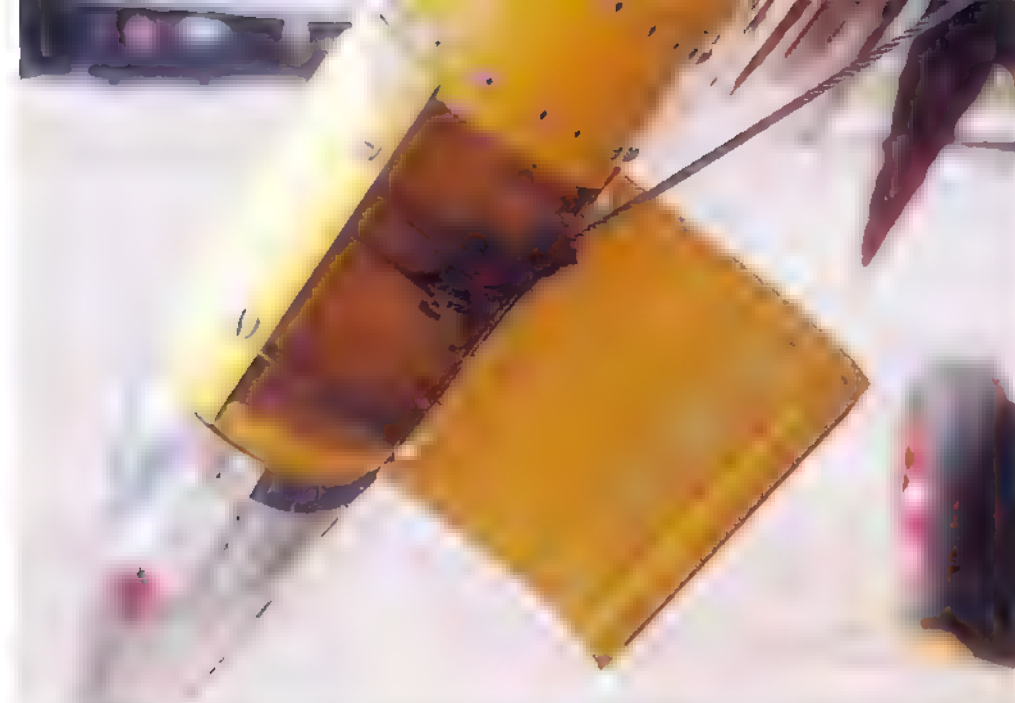
The metal tie-back cable was fastened to the cable enclosure located in the Avenger's wingtip. The cable loop was placed around a bolt, which was threaded through a bracket placed on the compartment's back wall. Washers separate the ribs from the cable loop. The cable was coiled inside the compartment and the two doors were fastened shut when this cable was removed from the horizontal stabilizer. (Glen Phillips)

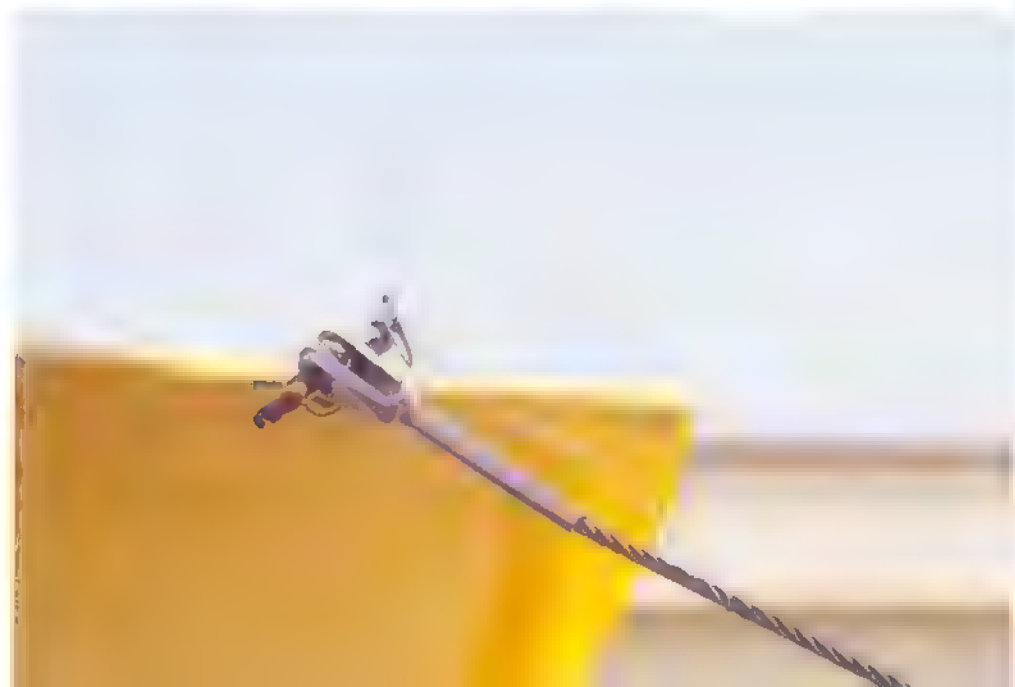
The wingtip tie-back cable was attached to a metal loop fixed to the horizontal stabilizer's leading edge. A bolt passed through the two loops at the cable's end, which enclosed the stabilizer's anchor loop when the tie-back cable was in use. The retaining wire keeps this bolt with the cable to prevent the bolt from being lost when not in use. Deck crewmen placed the tie-down cable on the tail after the pilot had hydraulically folded the wings back following recovery aboard the carrier. (Glen Phillips)

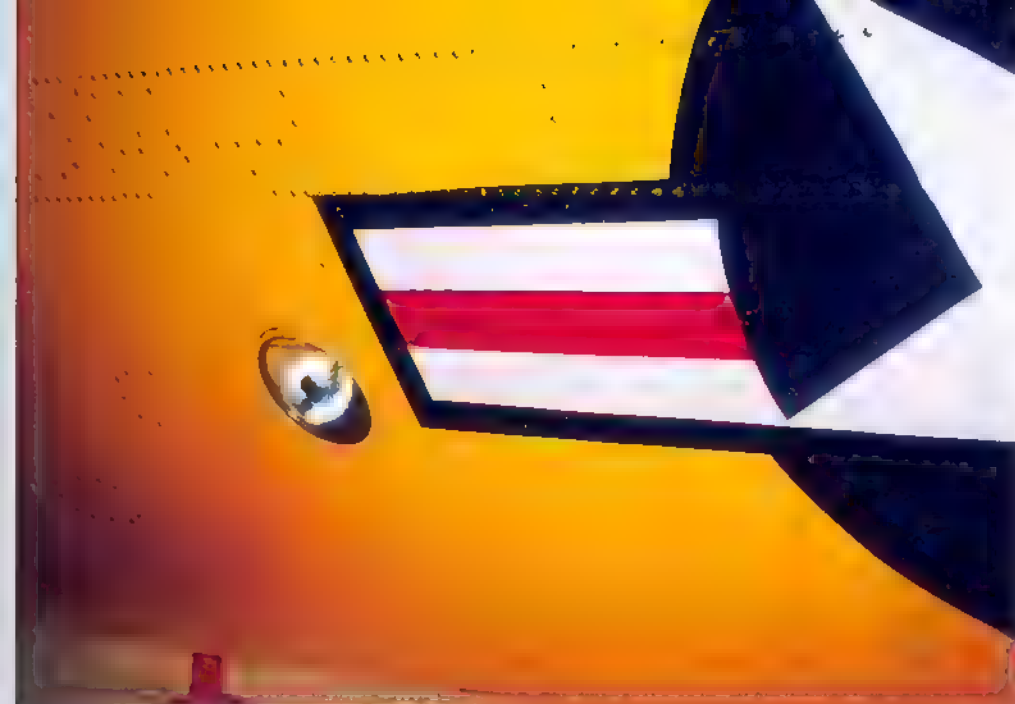
A clear landing light with a silver back was installed in the TBF/TBM's port outer wing. This light extended down 90° when in use, with the lens facing forward. The lamp was turned on for the aircraft's approach, landing, and taxiing at night or in bad weather. The Lone Star Flight Museum's Avenger was finished in the colors of a post-World War II utility squadron. US Navy utility squadrons flew various TBF/TBM models until the last Avenger was retired from USN service in early 1957. (Lou Drendel)

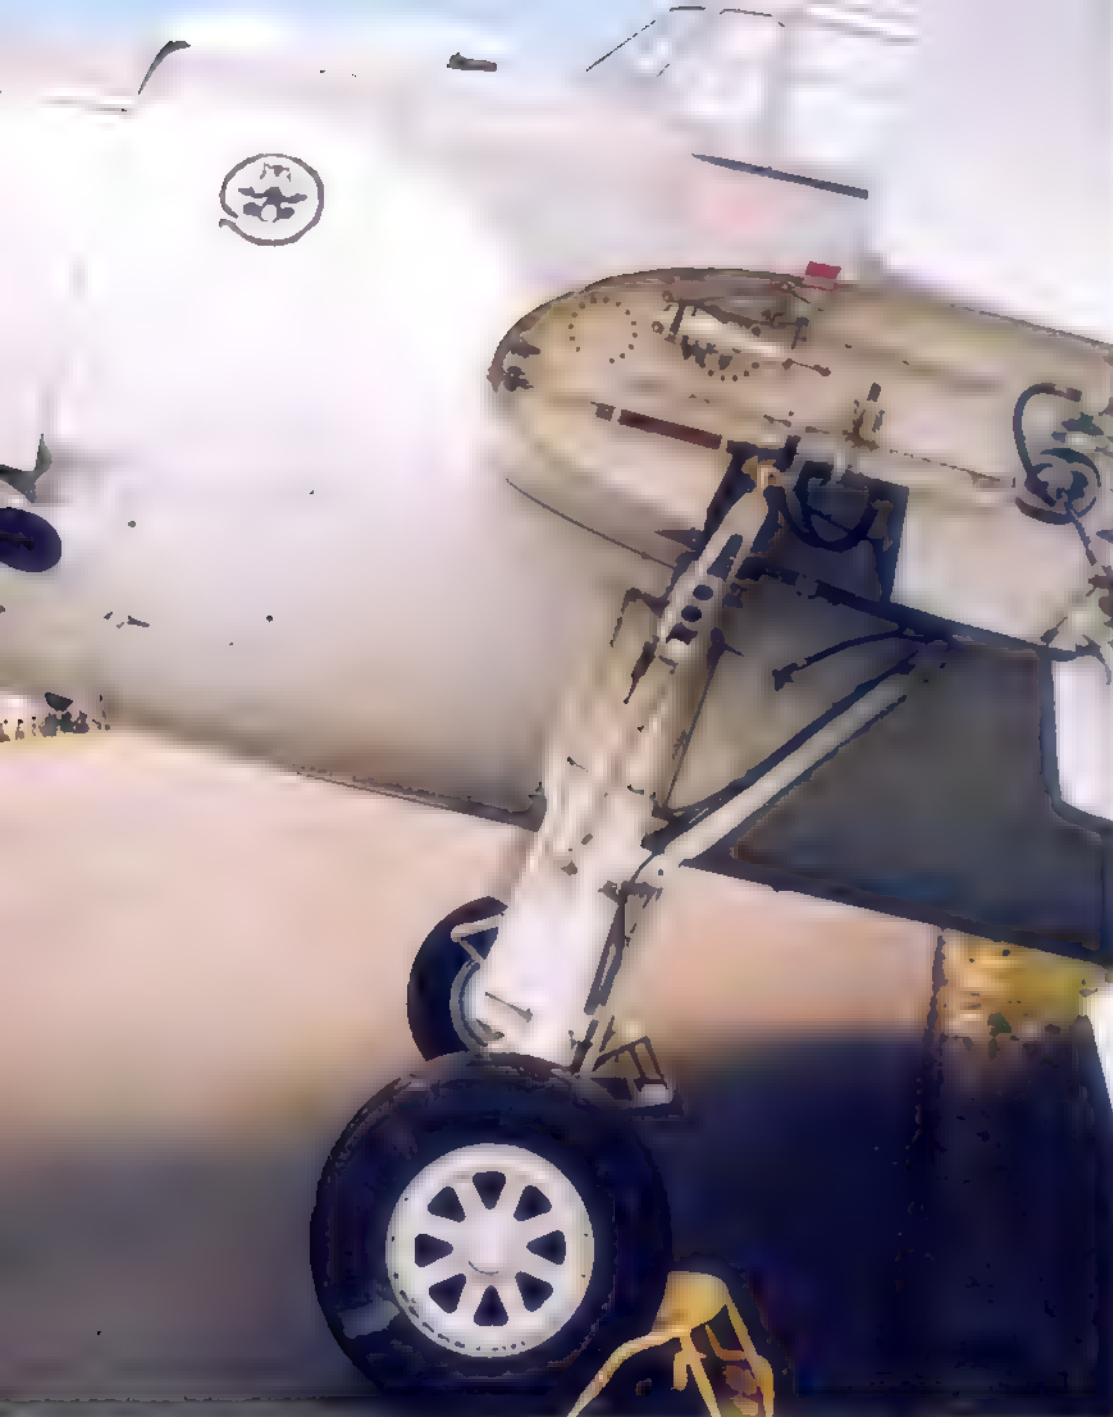
The main landing gear for all Avenger models operated hydraulically. This unit retracted outward and upward into the wheel wells located in the outboard wing panels. The gear retraction strut was mounted to the forward gear leg and the landing gear bay. Hydraulic pressure on this strut pulled up the landing gear leg on retraction and lowered the gear leg on extension. (Lou Drendel)

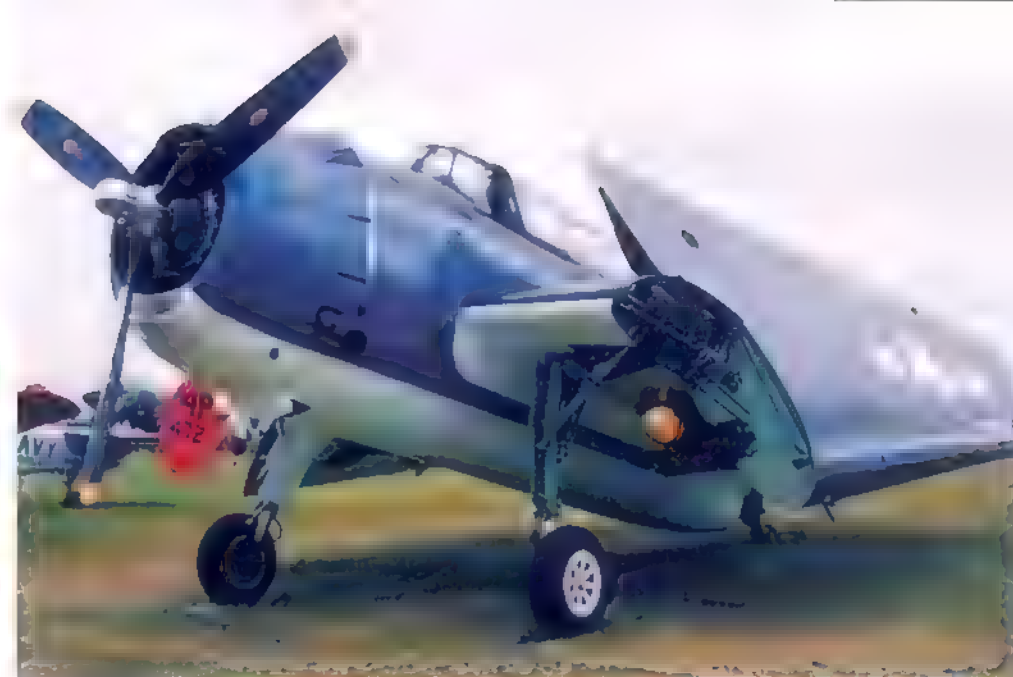
This restored TBM-3 was displayed with its wings folded back. A bomb rack with a simulated bomb was mounted under the inner wing section immediately aft of the landing gear. Carrier-based aircraft required strong landing gear assemblies to absorb the high stress of carrier landings. The Avenger's main landing gear was stressed for a vertical velocity of 16 feet (4.9 m) per second. (Lou Drendel)

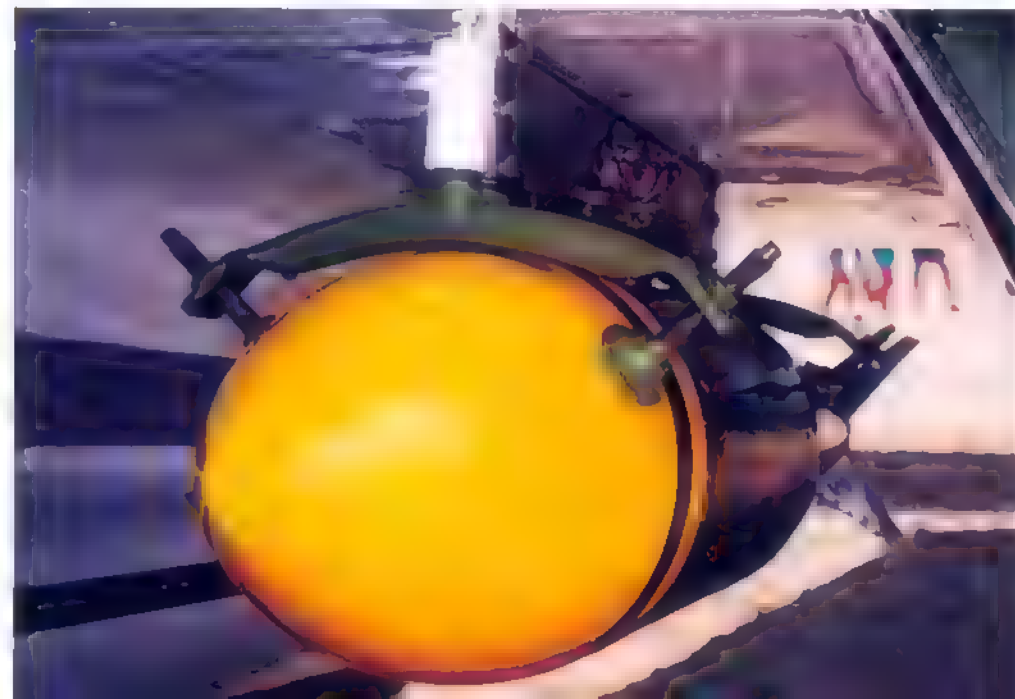
A simulated 500 pound (226.8 kg) bomb was loaded onto the TBM-3's inner wing bomb rack. Fore-and-aft pairs of sway braces kept the bomb steady until it was released from the aircraft. This bomb rack – introduced on the TBM-3 model – was seldom used on Avengers in service, since ordnance was usually loaded into the bomb bay. A 58 gallon (219.6 L) or 100 gallon (378.5 L) external fuel tank could also be mounted on this station. (Lou Drendel)

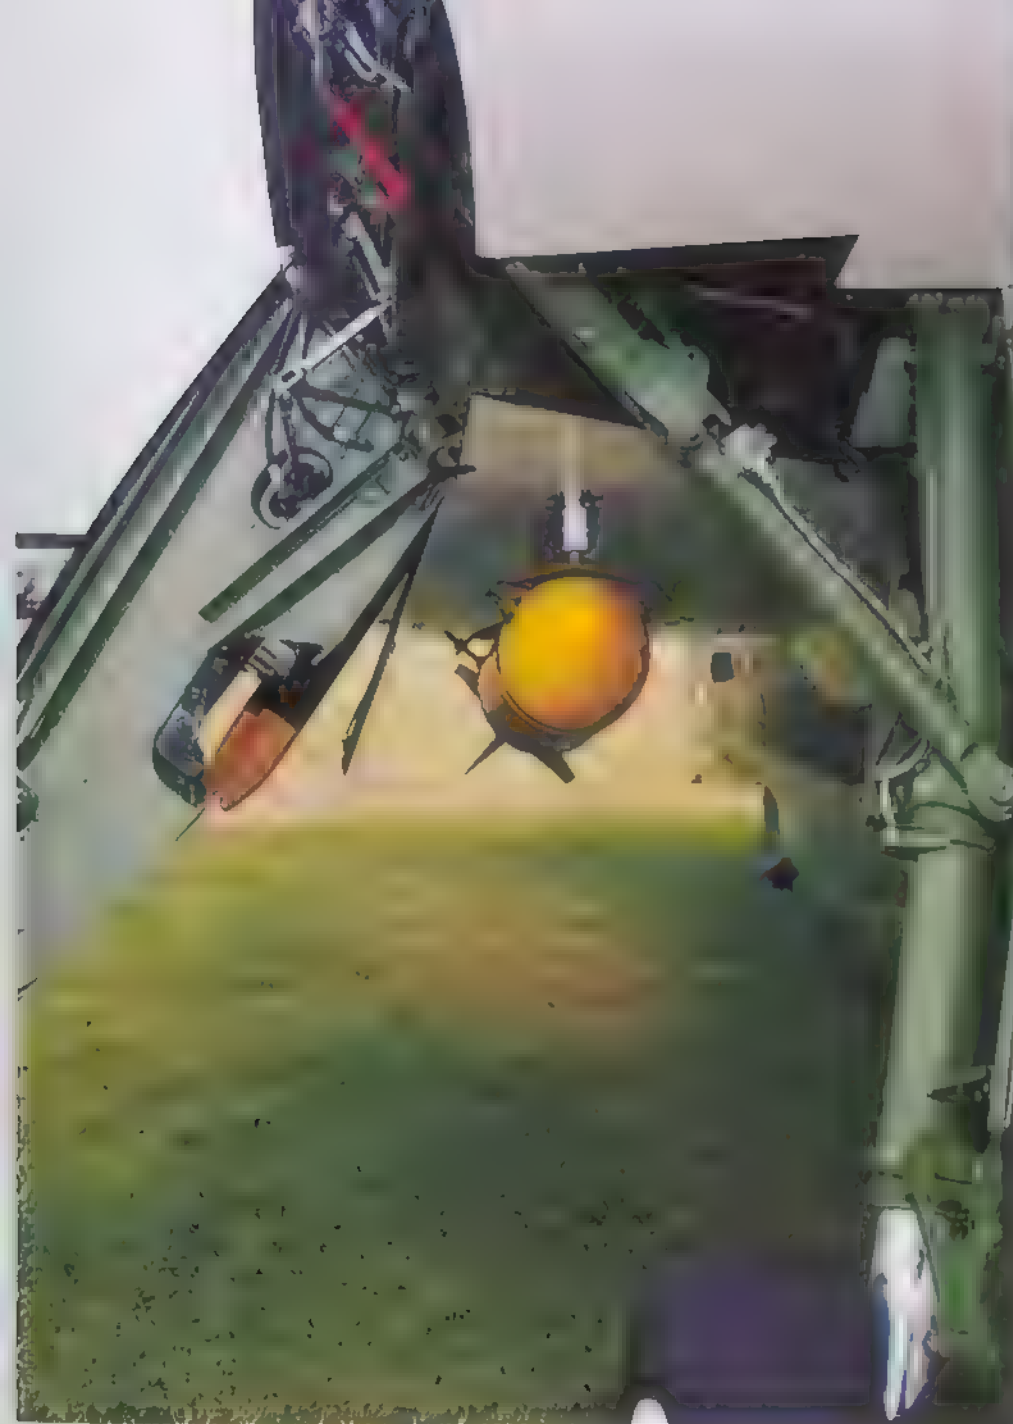
The main landing gear leg bent slightly outwards approximately halfway between the wing and the wheel hub. The scissor link connecting the upper and lower gear leg sections was mounted at the front, with the oleo (shock absorbing) strut left in chrome for smooth operation. The retraction strut folded inward during landing gear retraction. A micro switch mounted just below the retraction strut section joint governed the movement of the main and retraction struts. (Lou Drendel)

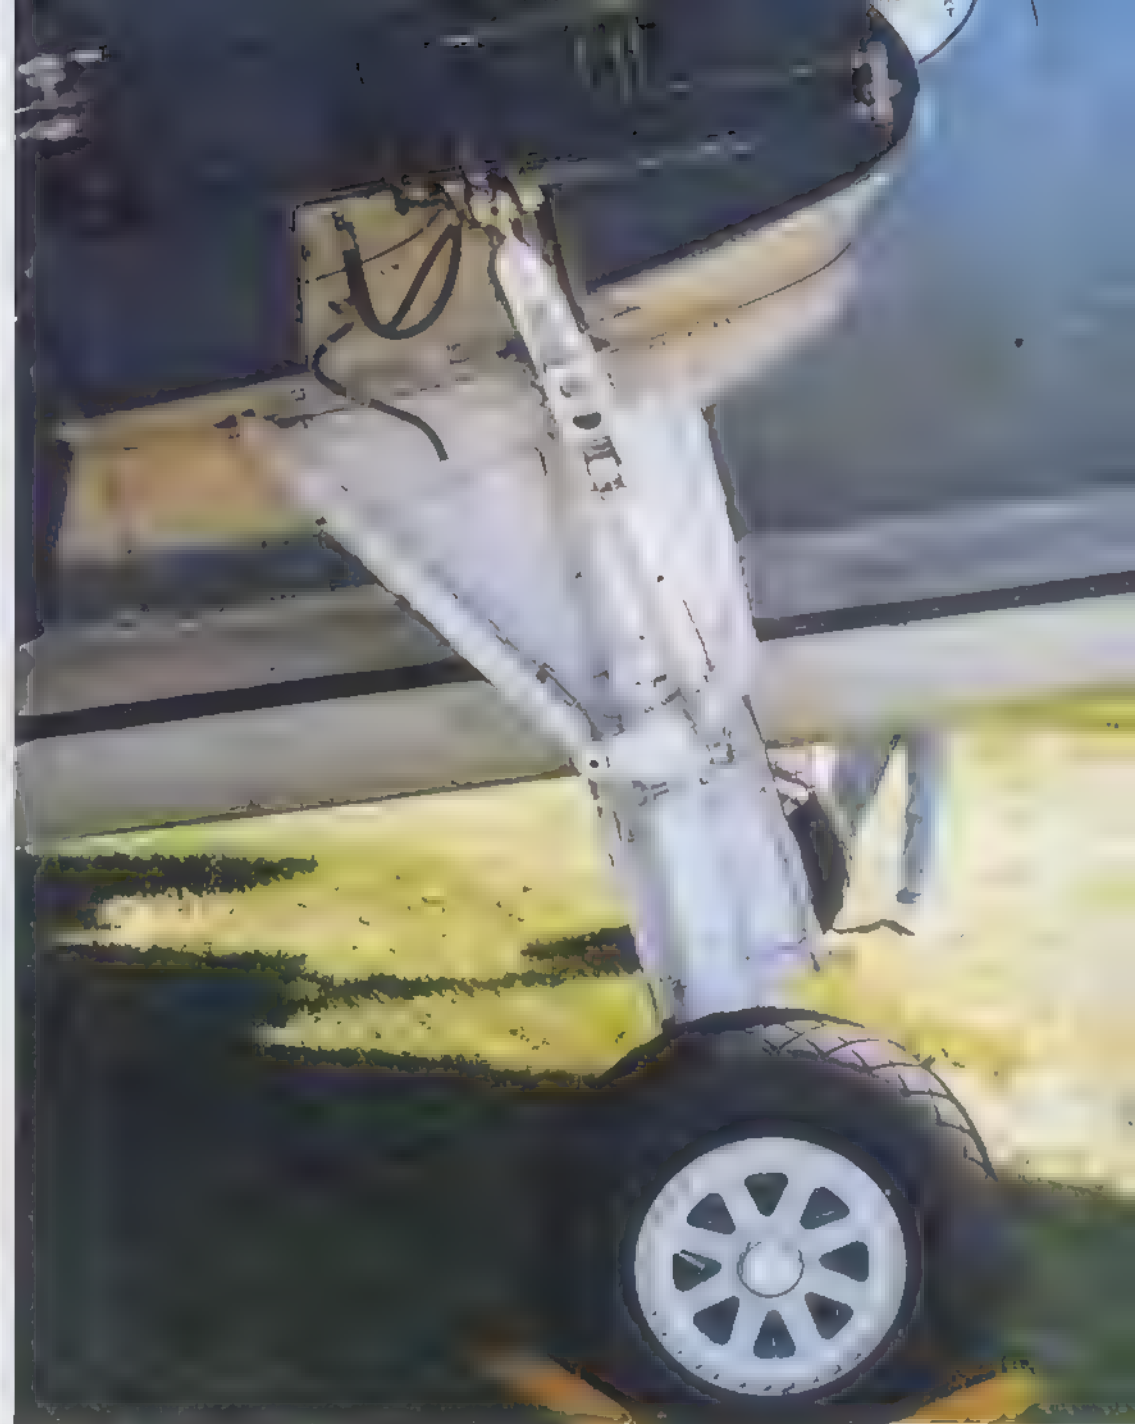
Each TBF/TBM main landing gear was equipped with a Goodyear ten-ply tire, which measured 34 inches (86.4 cm) in diameter by nine inches (22.9 cm) wide. The tire pressure was 110 pounds (49.9 kg) per square inch for carrier operations and 95 pounds (43.1 kg) per square inch for operating from land. The spoked wheel disc cover allowed air to cool the Goodyear hydraulic disc brake. The disc cover was removable to allow the tire and wheel to be removed and for servicing the brake. (Lou Drendel)
